**KIRK N. ELLIS & ASSOCIATES  
STRUCTURAL & CIVIL ENGINEERING, LTD.**

<b>DATE:</b> 01/29/2010	<b>JOB #:</b> 0410
<b>PROJECT:</b> RHA Residential Inspection	
<b>LOCATION:</b> 9200 Running Dog Circle	
<b>CONTRACTOR:</b> N/A	
<b>OWNER:</b> Reno Housing Authority	
<b>WEATHER:</b> Overcast	
<b>TEMP:</b> 34°F	<b>TIME:</b> 10:00AM
<b>PRESENT AT SITE:</b>	
Brian Wilcox – Kirk N. Ellis & Associates	
Kirk N. Ellis – Kirk N. Ellis & Associates

At the request of Tim O'Fallon of the Reno Housing Authority, this office went to conduct an Initial Structural Engineering Visual Inspection Site Visit for the residence located at 9200 Running Dog Circle. This residence is identified by the Washoe County Assessor as APN: 550-552-01, and listed as a Two Story, Single Family Townhouse End Style Residence built about 2005.

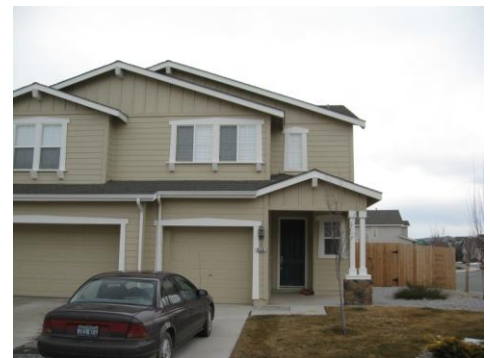
1. The exterior is composed of horizontal lap siding. See Figure 1. The exterior finish shows no sign of movement.
2. The interior of the residence appeared to have a relatively new or undamaged coat of interior paint. Reviewing the assessment data, it is highly probable that this residence has not had an occupant. A private party purchased this residence for only a month. If this paint is the original paint, any cracks and buckles would be highly visible. The rear sliding glass door had a minor diagonal hairline crack. The wall adjacent to the the door also had a hairline minor crack. See Figure 2 and Figure 3.

**FIG 1: EXTERIOR**

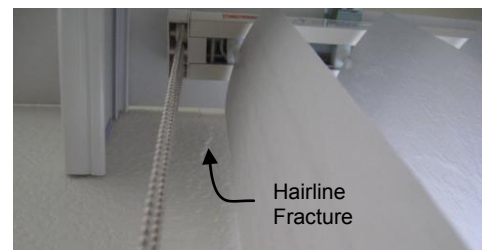
**FIG 2: MINOR GYP. BOARD FRACTURE AT CORNER OF SLIDING GLASS DOOR.**

displayed diagonal tension cracks. If the current coat of paint is the original coat of paint (it appears to be), then this structure has not moved very much. The cracks are probably just due to normal lumber drying shrinkage. With no additional cracking and no other racked openings the signs of movement appear to be localized. The exterior horizontal lap siding showed no signs of buckling, and the edge and field nailing showed no signs of elongating. This type of siding is extremely forgiving and can conceal defects and movement. Though no signs of movement were seen, this is no guarantee that movements have not occurred.

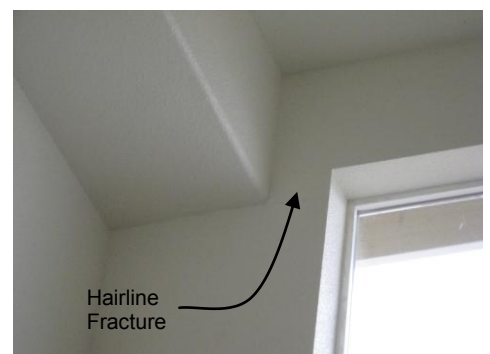
**FIG 3: MINOR HAIRLINE FRACTURE AT CORNER OF STRUCTURE.**

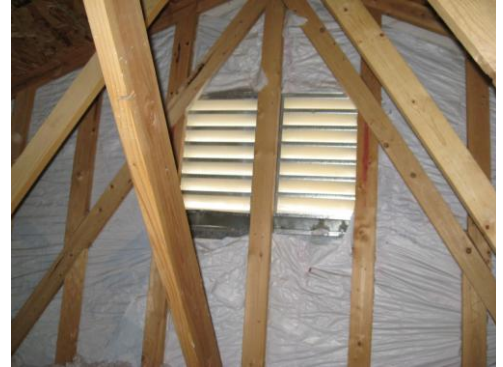
6. All areas accessible from the attic access point and above the insulation were inspected and appeared to be free from defect. The roof truss chords and webs did not have any visible stress fractures and no water damage was observed. There were no observed continuous lateral bracing. The exterior gable end walls did not appear to have sheathing. See Figure 4.

FIG 4: STRUCTURAL GABLE END.

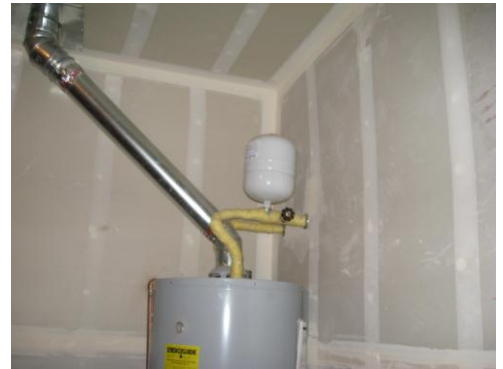
8. The mechanical equipment, in both the garage and the attic, appear to be seismically braced. See Figure 5 and Figure 6.

FIG 5: WATER HEATER, STRAPS NOT SHOWN.

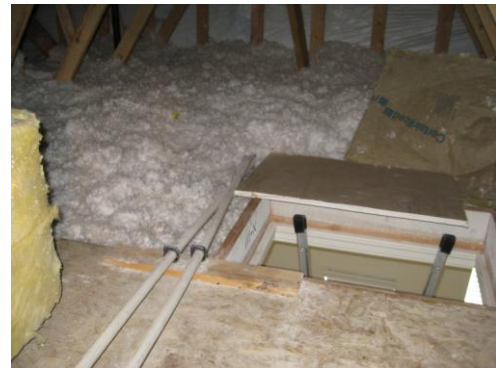
FIG 6: PLATFORM FOR THE ATTIC MECHANICAL EQUIPMENT.
