KIRK N. ELLIS & ASSOCIATES
STRUCTURAL & CIVIL ENGINEERING, LTD.
245 East Liberty Street, Suite #425
Reno, Nevada 89501
Phone: (775) 322-7723 - Fax: (775) 322-5372
<http://www.kneassoc.com>

DATE: 01/05/2010	JOB #: 1309
PROJECT: Vicks Residence	
LOCATION: 2445 Faretto Lane, Reno, NV	
CONTRACTOR: Wasik Construction	
OWNER: Steven & Jackie Vicks	
WEATHER: Haze	
TEMP: 27°F	TIME: 8:00
PRESENT AT SITE:	
Wasik Construction	
Brian Wilcox – Kirk N. Ellis & Associates

F I E L D R E P O R T

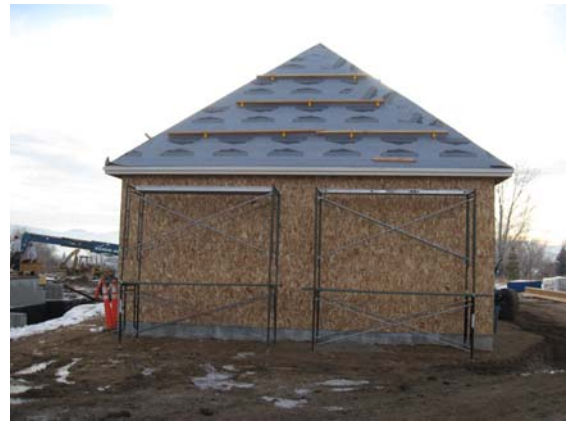
FIGURE 1 – COMPLETED UPPER GARAGE

1. The upper garage was nearing structural completion. The foundations, walls, roof trusses and all faces sheathed. See Figure 1.
2. The Simpson Strong Walls appear to have been correctly installed and most of the other required Simpson hardware (hangers, straps and hurricane ties) are installed. The H1 hurricane ties are installed on the interior of the structure. See Figure 2. This is contrary to the structural drawings. Refer to detail 1/S4.3. The H1 is ineffective on the interior face of the structure unless the top chord is connected directly to the studs adjacent to the connection point. If the contractor wishes to continue connecting the H1's to the interior, he will need to request a change and additional hardware will be required.

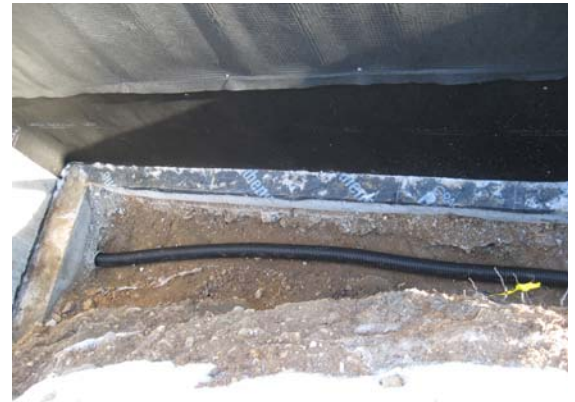
FIGURE 3 – DRAINAGE AND STEM WALL INSULATION

3. The basement garage walls are up and no longer in forms. Drainage to daylight has been installed at both the footing and at the window area wells. See Figure 3. The stem wall insulation and moisture barrier has also been installed.

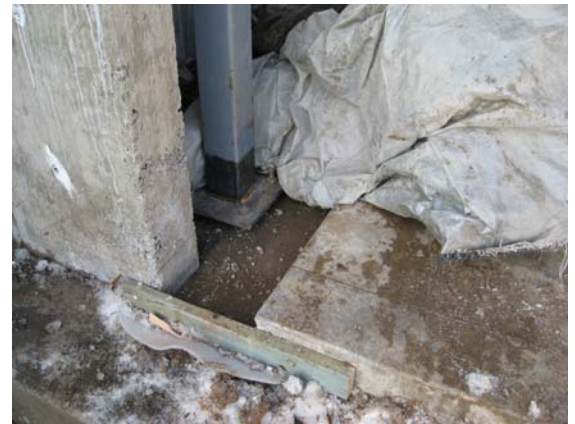
FIGURE 4 – COLUMN BASE PLATE BLOCK-OUT

4. Columns and base plates for the columns are installed. Block-outs for the base plates in the slab are present, but no grout or additional concrete was observed. See Figure 4.

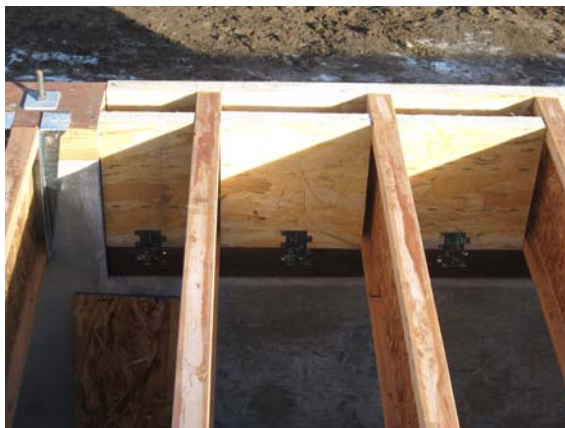
FIGURE 5 – JOIST AND RIM BOARDS INSTALLED PER PLANS

6. The main level floor joists are installed. The rim boards and blocking are installed where required and the hangers are welded/nailed where required (See Figure 5). Additionally, all the hangers are glued. This was not required, but it does decrease the incidence of squeaky floors.

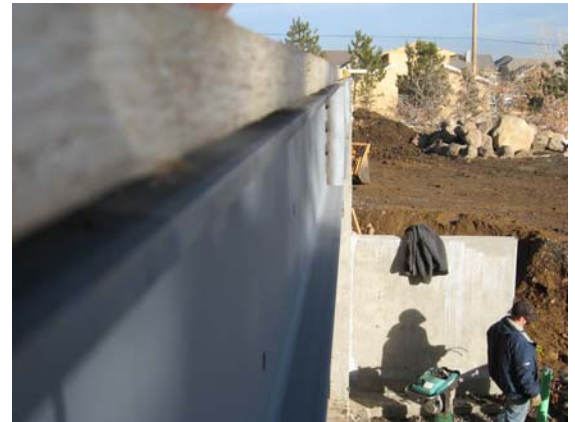
FIGURE 6 – SPACING BETWEEN HEADER AND SHEATHING.

7. The main level floor sheathing was in the process of being installed. The 1-1/8" floor sheathing was being installed with glue and screw nails as per the structural details. This should significantly decrease any incidences of sound from the structural floor framing. There is a 1/2" gap between the steel garage beam header and the floor sheathing. See Figure 6. This will need to be shimmed and the length of the powder driven pin increased to compensate.

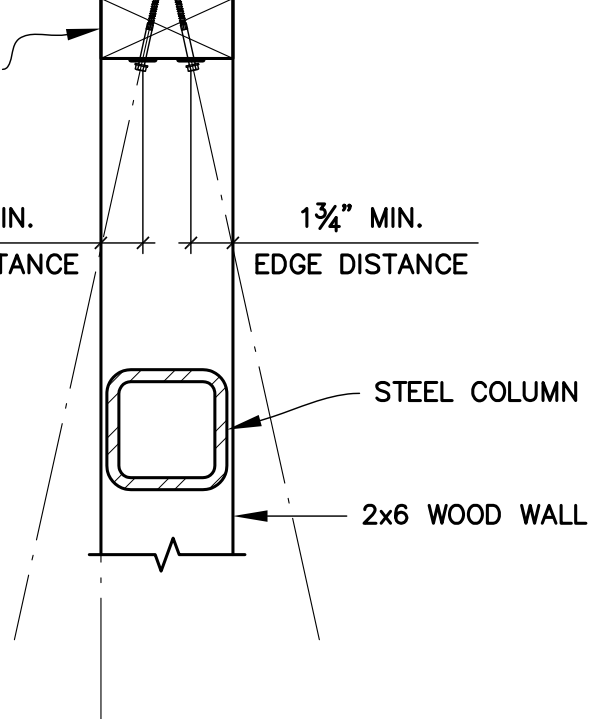
NEW END WALL CONNECTION AT RESTRICTED CLEARANCE

P.T. D.F. 3x6 \bar{R} w/ (2) ROWS SIMPSON
TTN25400H w/ CODE APPROVED
WASHER AT 8" O.C. STAGG'D TO NET
4" O.C. MAX. TYP. U.N.O.

1 3/4" MIN. 1 3/4" MIN.
EDGE DISTANCE EDGE DISTANCE

5. Interior bearing and non structural wall appear to be structurally complete. There are a few interior bearing walls that run perpendicular to the joist above that are not installed per the structural plans. In lieu of stopping the structural wall below the floor joists and blocking above to connect to the first floor sheathing (Refer to Detail 7/S4.1), the wall is framed to the bottom of sheathing. This is an acceptable solution and no further work is necessary. There is one location that the contractor is having difficulty complying with the structural drawings. Refer to Field revision FR-04 for additional information.
