**KIRK N. ELLIS & ASSOCIATES
STRUCTURAL & CIVIL ENGINEERING, LTD.**

DATE:	10/28/09	JOB #:	1309
PROJECT:	Vicks Residence		
LOCATION:	2445 Faretto Lane		
CONTRACTOR:	Wasik Construction		
OWNER:	Steve & Jackie Vicks		
WEATHER:	Scattered Clouds		
TEMPERATURE:	32°F	TIME:	8:45am
PRESENT AT SITE:			
L&H Concrete			
Brian Wilcox – Kirk N. Ellis & Associates

REPORT DATE: 11/02/2009

As part of Kirk N. Ellis & Associates Construction Phase Support, this office went to inspect the current state and quality of construction at the residence located at 2445 Faretto Lane, Reno, Nevada.

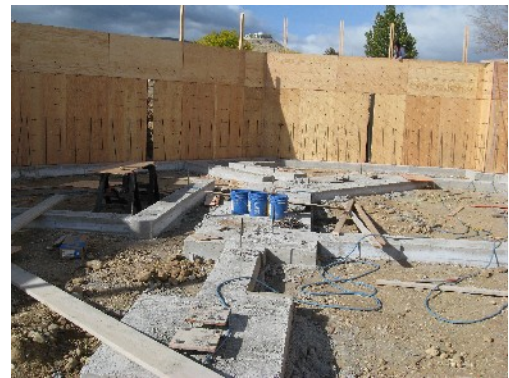
1. The basement concrete footings had been poured. See Fig 1.
2. Structural steel anchor bolts and structural holddown anchors had been placed.
3. The basement level concrete walls were in the process of being formed. No rebar had been placed other than the footing dowels.
4. Window well locations are at varying states of construction and the slab/curb dowels for those areas are present.
5. The base for the structural slab had not been installed at time of inspection.

FIG 1: FOUNDATIONS Poured and STRUCTURAL BASEMENT RETAINING WALLS IN THE PROCESS OF BEING FORMED.

All structural members and systems, at their current states of construction, appear to be in full compliance with the structural plans. While it is very early in the process of construction, we typically see most problems starting at the foundation phase. If current quality of construction is maintained, this structure should be quite exceptional.

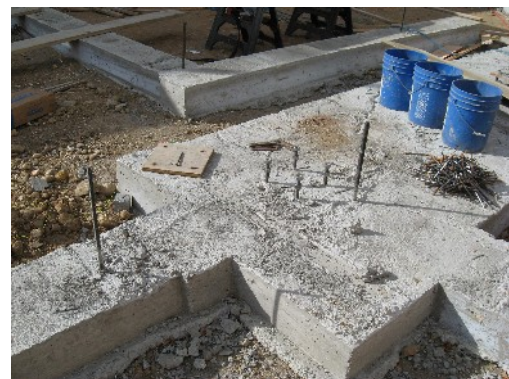
FIG 2: ANCHOR BOLTS AND HOLDDOWN ANCHORS CAST IN PLACE.
